# Best Practices of Small-to-Medium-Sized Buildings – The 1<sup>st</sup> Report

- Introduction of the building owners' efforts in the changing times -

September 24, 2019

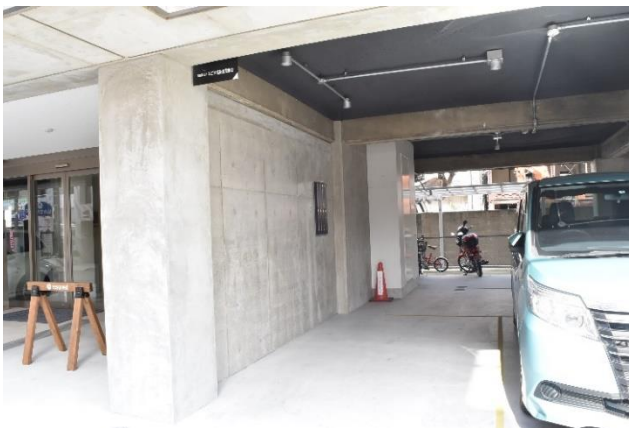
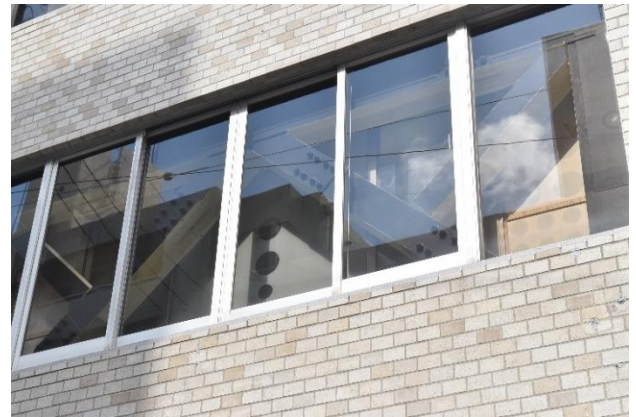
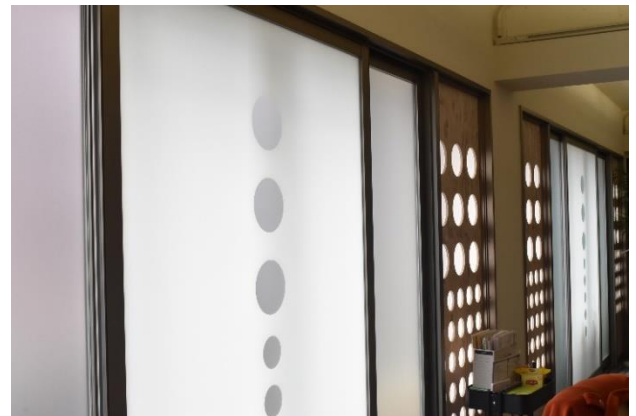
Earthquake-resistant walls and a column covered with aramid fibers on the 1<sup>st</sup> floor (left)

Braces from outside (upper right) and inside of the room (lower right)

For the first floor, the earthquake-resistant walls were installed and the columns were reinforced by using aramid fibers. For the upstairs, steel braces were applied inside of the building not to cause damage of external view. At installation of the braces, carrying the complete products into the rooms was impossible due to their size and weight, and thus the components were put together at each floor. They installed a heavy component of approximately 700 kilograms using a pulley to make it with a small manpower.

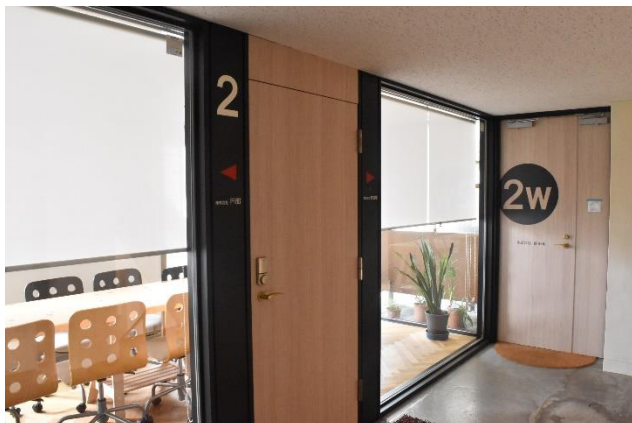
Glass walls of an office

**Glass-walls of the office:** The walls of the meeting rooms were replaced by the glass plates standing from the floor to the ceiling to give a spacious look.

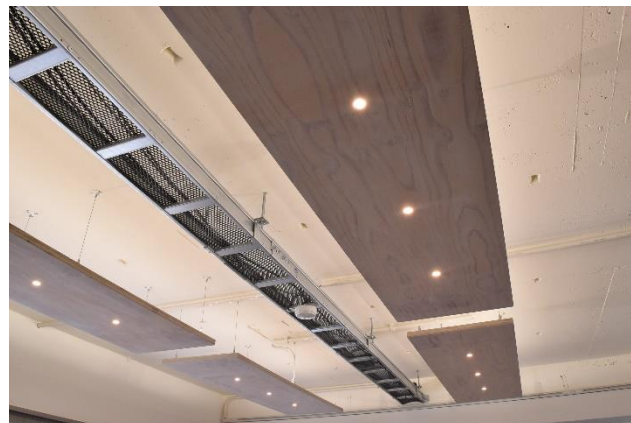
The suspended ceilings were removed, and the indirect lightings were attached directly to the ceiling.

**Removal of the suspended ceilings:** In the rooms of smaller than 100 square meters, the suspended ceilings were removed and the lighting apparatuses were attached directly to the ceilings. Indirect lightings are used mainly, and the rails for the lighting apparatuses were installed for the tenants to accommodate the position and lighting intensity as needed by their usage.

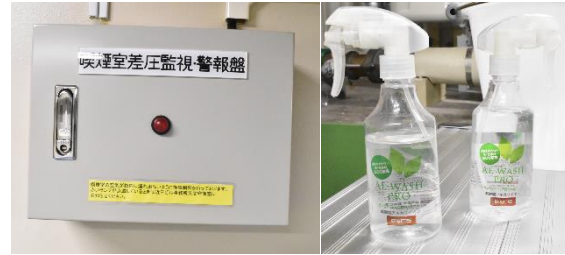
A DP alarm in the smoking room and environment-friendly detergents

Because seismic retrofitting and renovation from 2014 permitted the building to overcome the issues pointed out, the company reattempted LEED acquisition. This time, the company applied for it following the new rating system called "Arc" performance platform (that measures building performance by comparing metrics across the globe), and made a success of acquiring LEED Gold certification in 2018. Besides renovation, the company implemented environment- and human-friendly measures such as placing mats at the entrances for an anti-dust purpose, production and installation of a differential pressure (DP) monitoring and alarming device to maintain negative pressure in the smoking room, provision of face masks to the cleaning staff, and use of detergents made from natural ingredients.

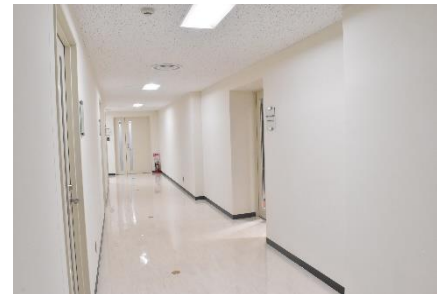
A floor plotted by earthquake-resistant

In 2014 when a key tenant moved out and the occupancy rate went down to approximately 50%, the owner recognized a necessity for renovation strongly, facing relative degradation in the functionality of the shared spaces including restrooms. Also, because the 1<sup>st</sup> seismic retrofitting in 2006 did not attain "Is" <sup>4</sup>0.6, the company started the 2<sup>nd</sup> retrofitting in which "the earthquake resistant studs system" was employed to strengthen the exterior walls excluding the windows using reinforced concrete walls. Although the system decreased the rentable ratio of the building with the thickened exterior walls and the interior strengthening walls, the owner made safety of tenants a primary concern. In addition, the company changed its floor layouts of the building to be consistent with the number of earthquake-resistant walls in each floor. For example, with a smaller number of earthquake-resistant walls, now the 7<sup>th</sup> store is the only floor to be leased at whole floor having more than 120 tsubo rentable area. Because these layouts coincide with the needs of the clients in the surrounding area, now the building has the tenants occupying a small space of 10 to 40 tsubo and keeps 100% occupancy rate. Moreover, for the tenants having difficulty to prepare a meeting room and/or a smoking room in their own space due to low utilization rate, the building provides a rental meeting room and a shared smoking room in the first basement and the mezzanine floor, respectively.
